FIRE PERFORMANCE EVALUATION OF WOOD VENEER WALLCOVERING, IN ACCORDANCE WITH THE 2006 EDITION OF NATIONAL FIRE PROTECTION ASSOCIATION 286, *STANDARD METHODS OF FIRE TESTS FOR EVALUATING CONTRIBUTION OF WALL AND CEILING INTERIOR FINISH TO ROOM FIRE GROWTH*

TRADE NAME: SANFOOT

SwRI Project No. 01.12703.01.233
Test Date: September 14, 2007
Report Date: October 11, 2007

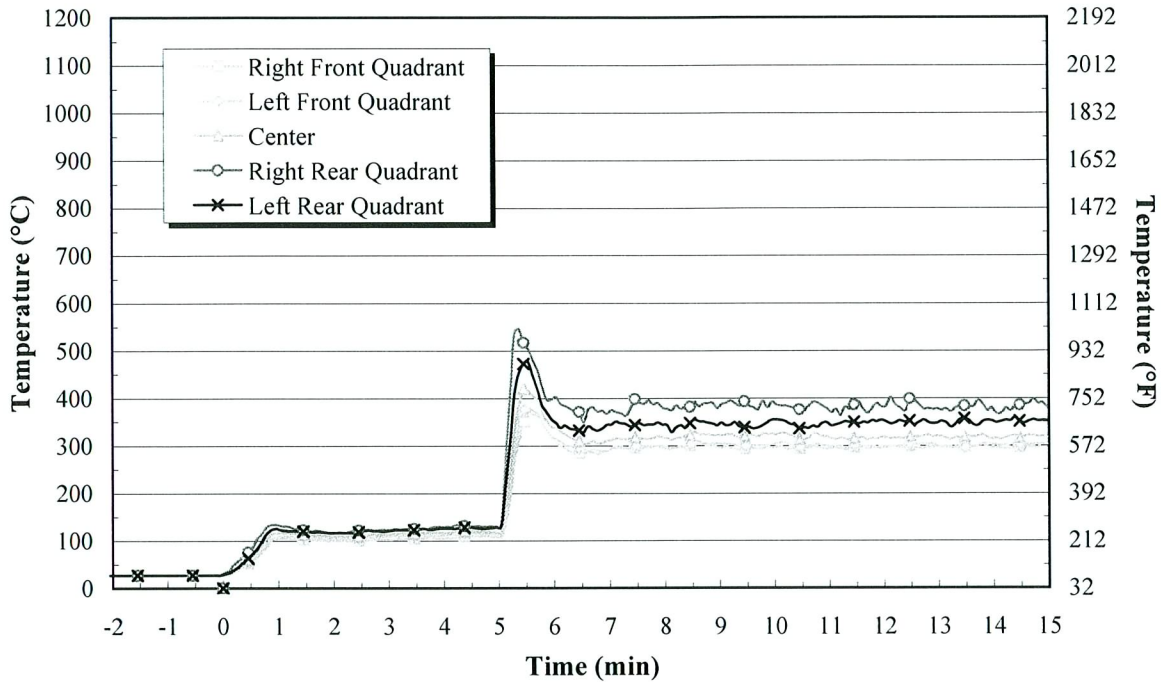
UPPER LAYER TEMPERATURES

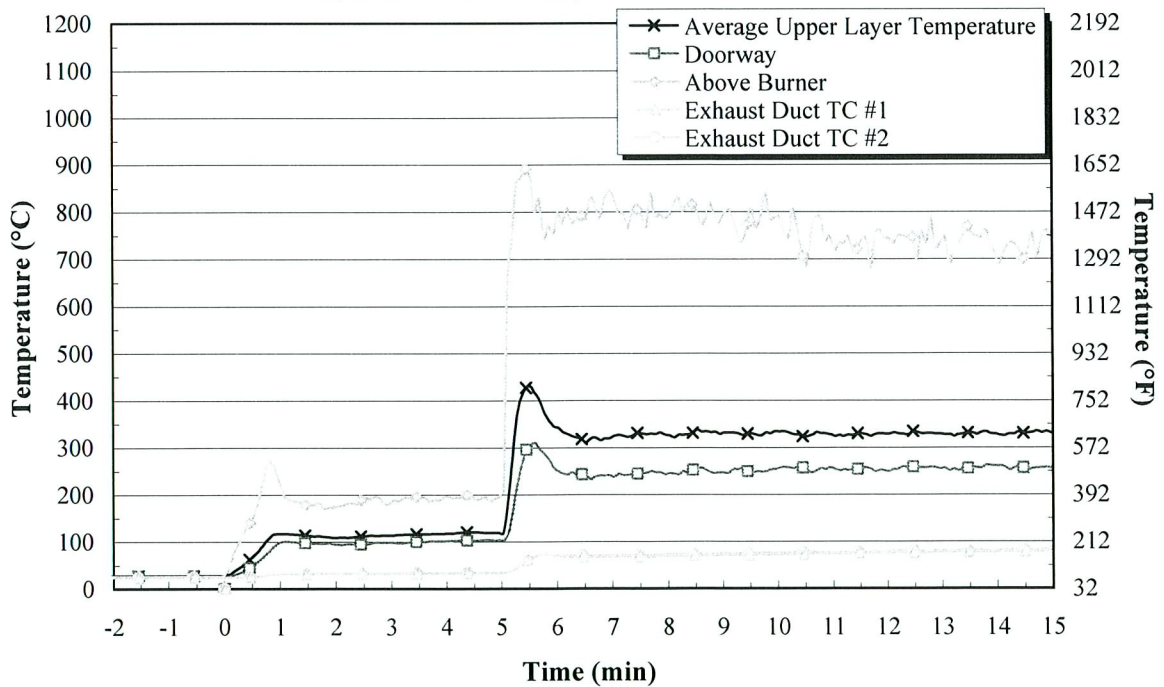
DOORWAY, ABOVE BURNER, AND DUCT TEMPERATURES

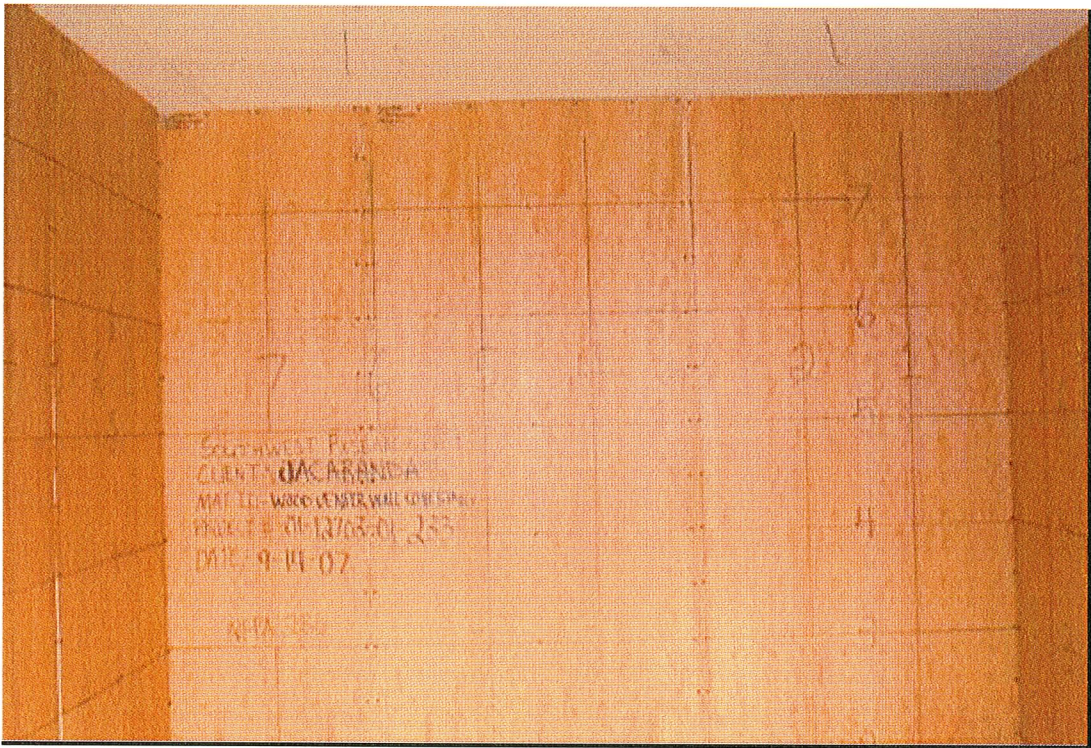
Figure B-1. Completed Test Room Assembly.

The 8 × 8-ft back wall, 8 × 12-ft sidewalls, and 8 × 12-ft ceiling of the test room were covered with the *Wood Veneer Wallcovering* and ½-in. gypsum wallboard panels. The panels were mechanically fastened to the test walls using screws every 6 in. on center around the perimeter and every 12 in. on center up the middle. See Figure B-1 for a picture of the completed assembly.

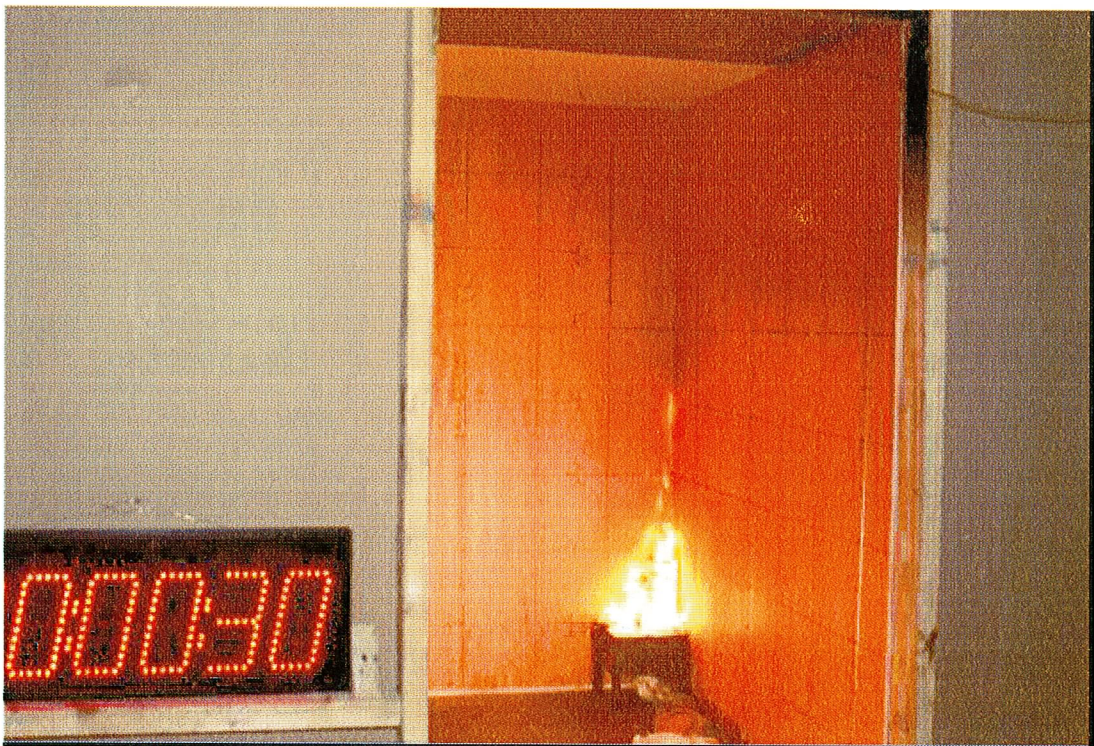
Figure B-2. Start of Test; Burner Set to 40 kW.

TIME MIN : SEC	VISUAL OBSERVATIONS
00:00	Start of Test, burner set at 40 kW.
00:10	Flames from the burner are 3 to 3½ ft in height.
00:25	Discoloration and scorching on the wood veneer wallcovering at direct flame impingement from the burner.

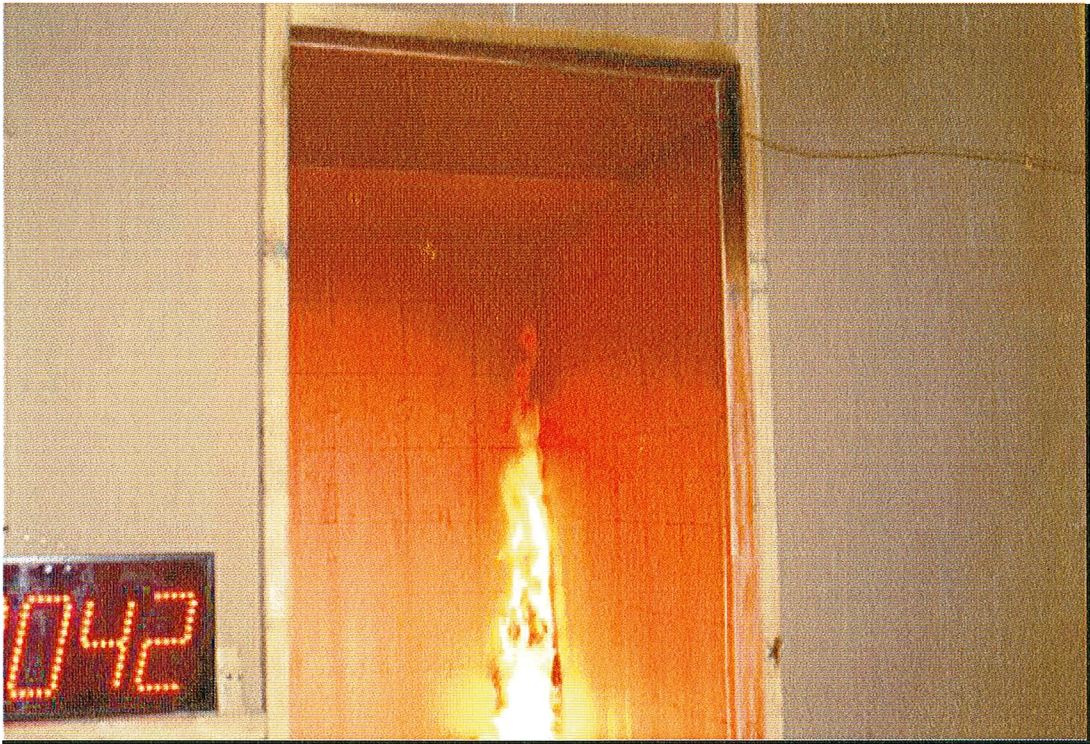
Figure B-3. View of Burner Corner; 42 s into Test.

00:32	Ignition on the back wall in the burner corner from 1 to 2 ft in height.
00:38	Flames in the burner corner are up to 5 ft in height.
00:41	Flames in the burner corner are 6 ft in height.

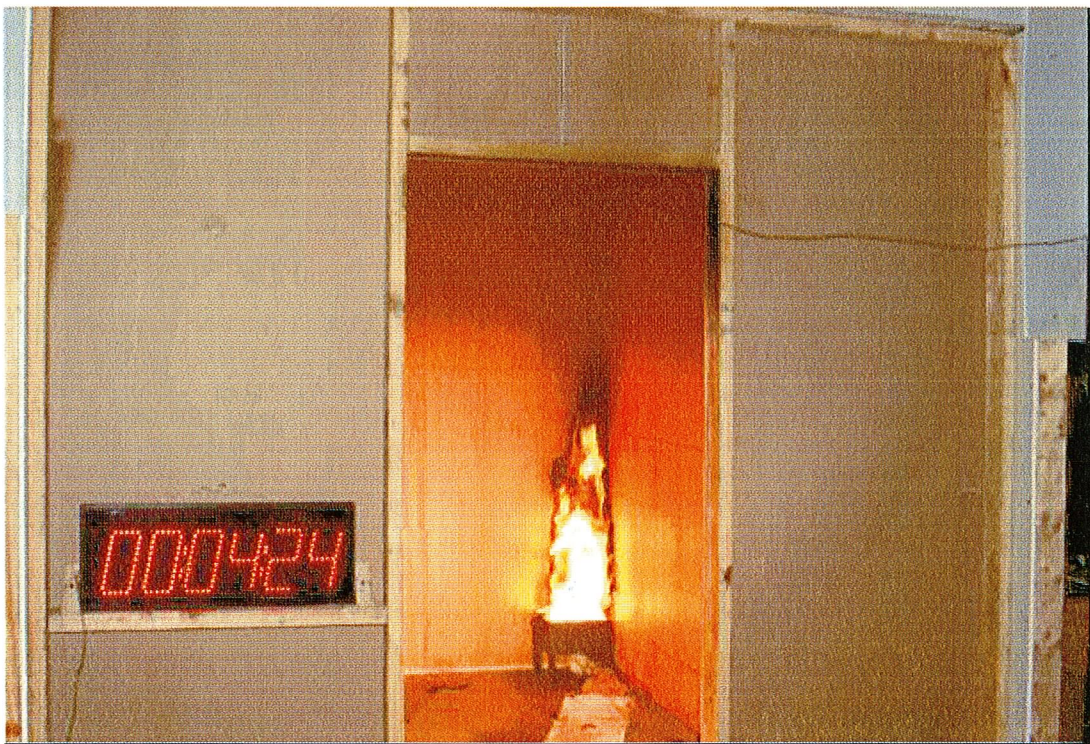
Figure B-4. View of Burner Corner; 4 min 24 s into Test.

02:15	Flames from the burner are 3–3½ ft in height.
04:00	Reignition of the wood veneer wallcovering burning vertically on the right wall from 1–3 ft in height and approximately 4 in. in width. Reignition on the back wall with same results.

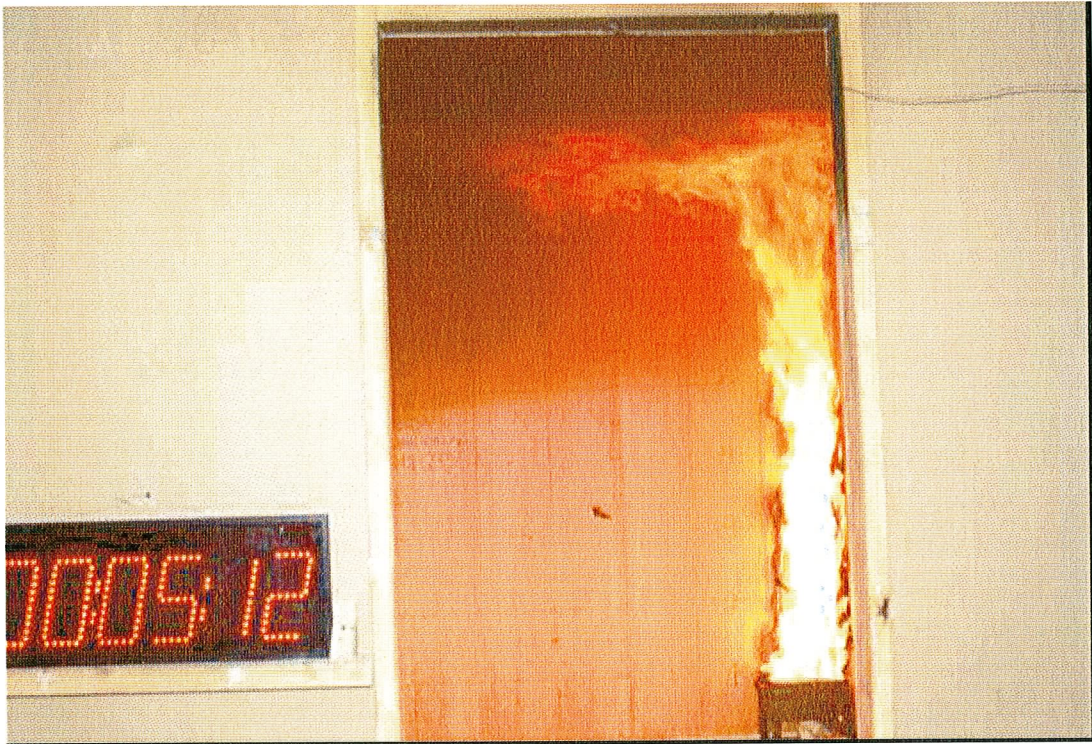
Figure B-5. View of Back Wall; Burner Increased to 160 kW; 5 min 12 s into Test.

05:00	Burner increased to 160 kW. Flames from the burner are up to the ceiling and flashing 1–2 ft along both walls at the ceiling.
05:10	Flames from the burner are up to the ceiling and burning 5–6 ft along both walls at the ceiling. The wallcovering is burning approximately 12 in. in width along both walls forming the burner corner.

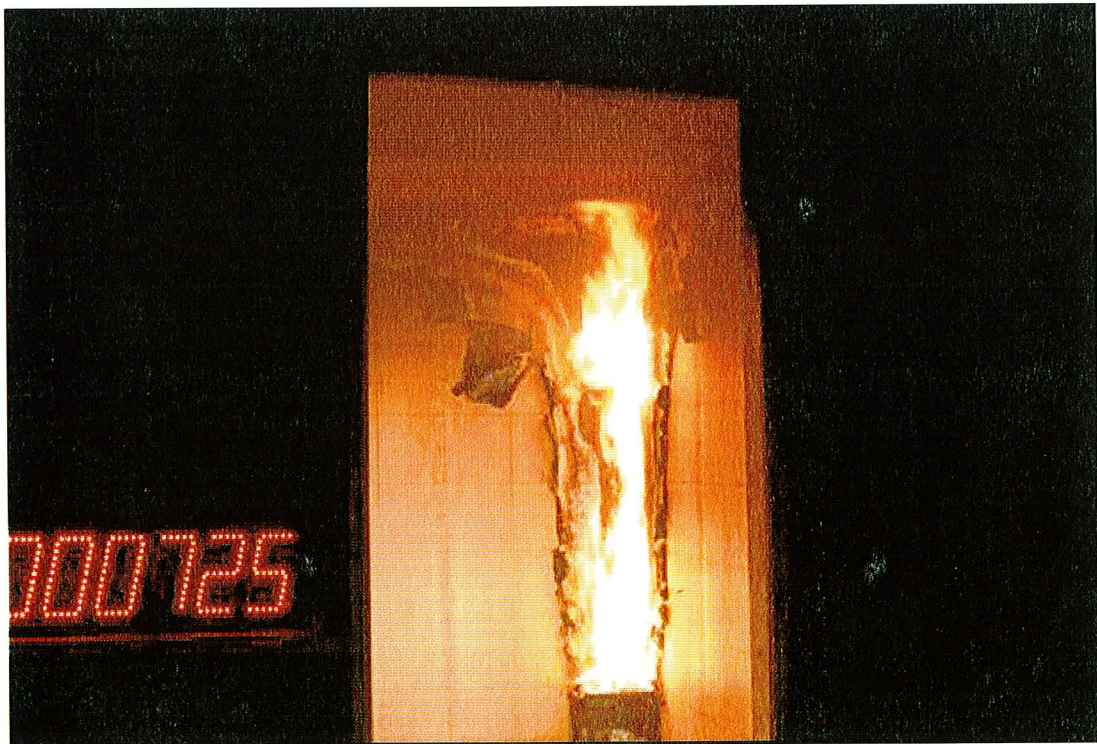
Figure B-6. View of Burner Corner; 7 min 25 s into Test.

07:00	Flames from the burner are up to the ceiling and flashing 1–2 ft along both walls at the ceiling. Light grey smoke down to 5½ ft above the floor.

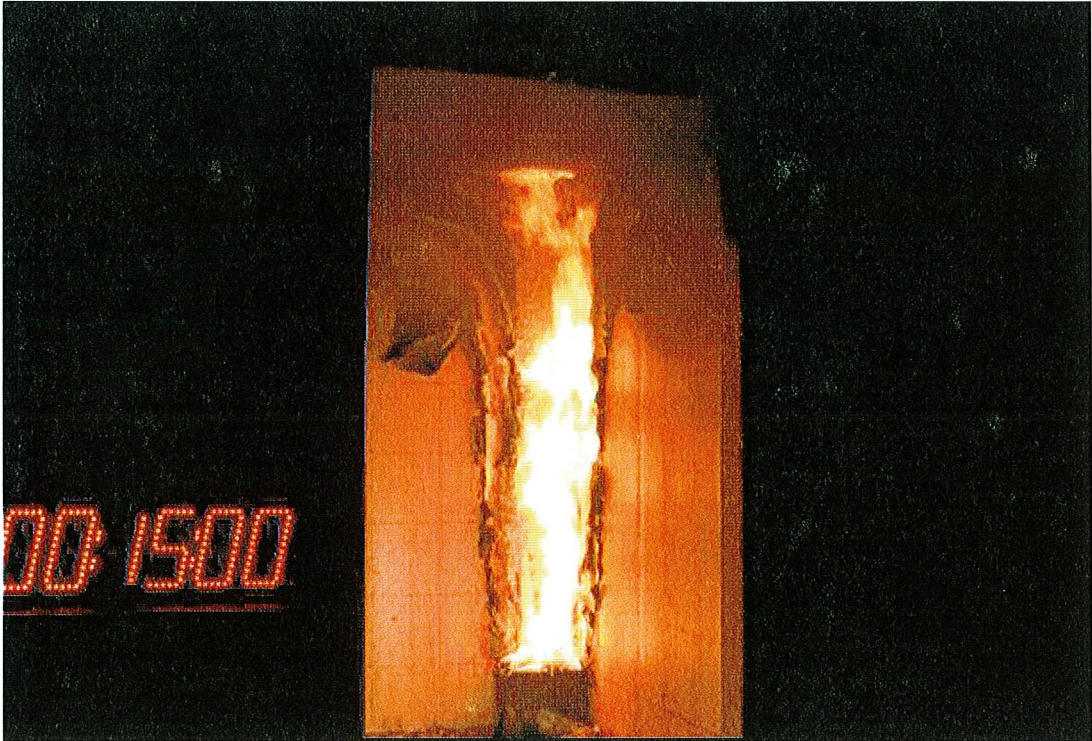
Figure B-7. View of Burner Corner; 15 min into Test; Test Complete.

10:00	No change.
14:30	No surface flaming of the wood veneer wallcovering.
15:00	End of Test, burner extinguished.

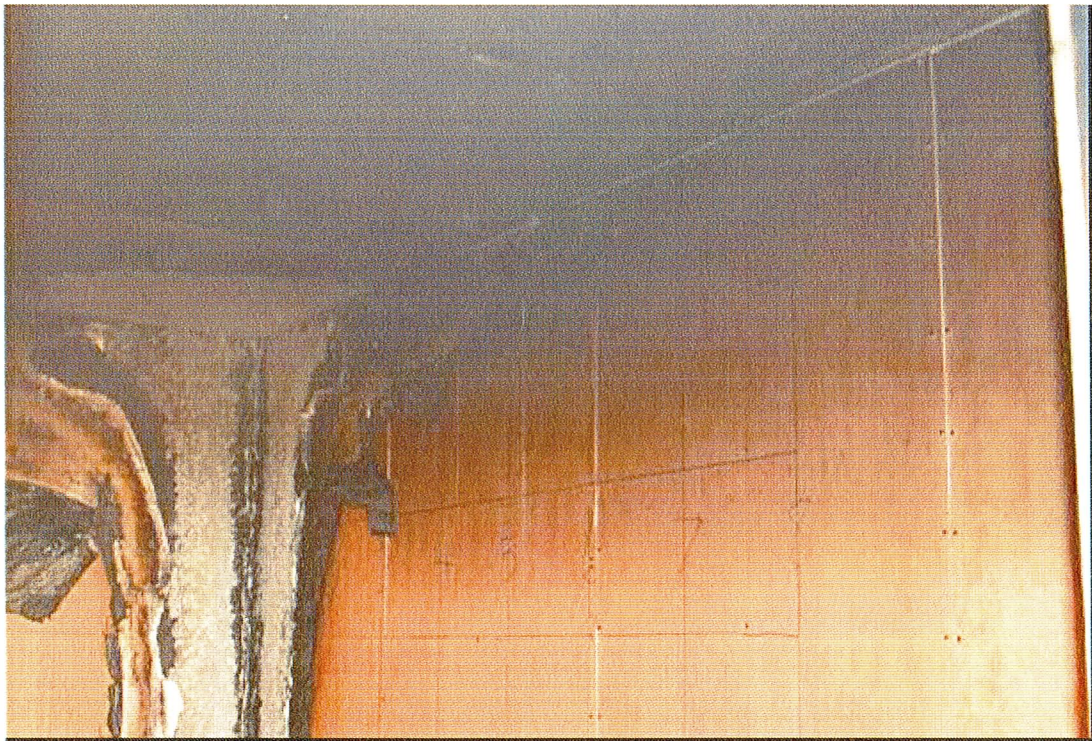
Figure B-8. End of Test; View of Right Wall at Ceiling.

Damage to the room interior measured approximately 14 in. in width along both walls up to the ceiling. The back wall was burned 6 ft from the burner corner, approximately 1 ft down from the ceiling.

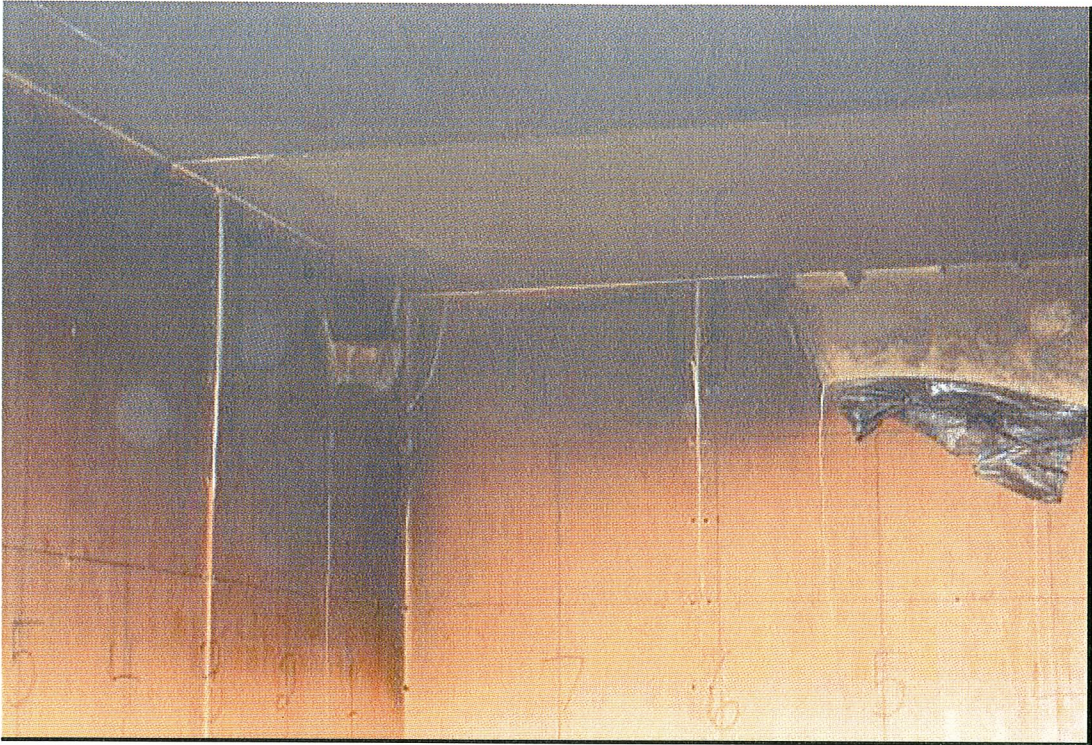
Figure B-9. End of Test; View of Back Corner Opposite Burner.

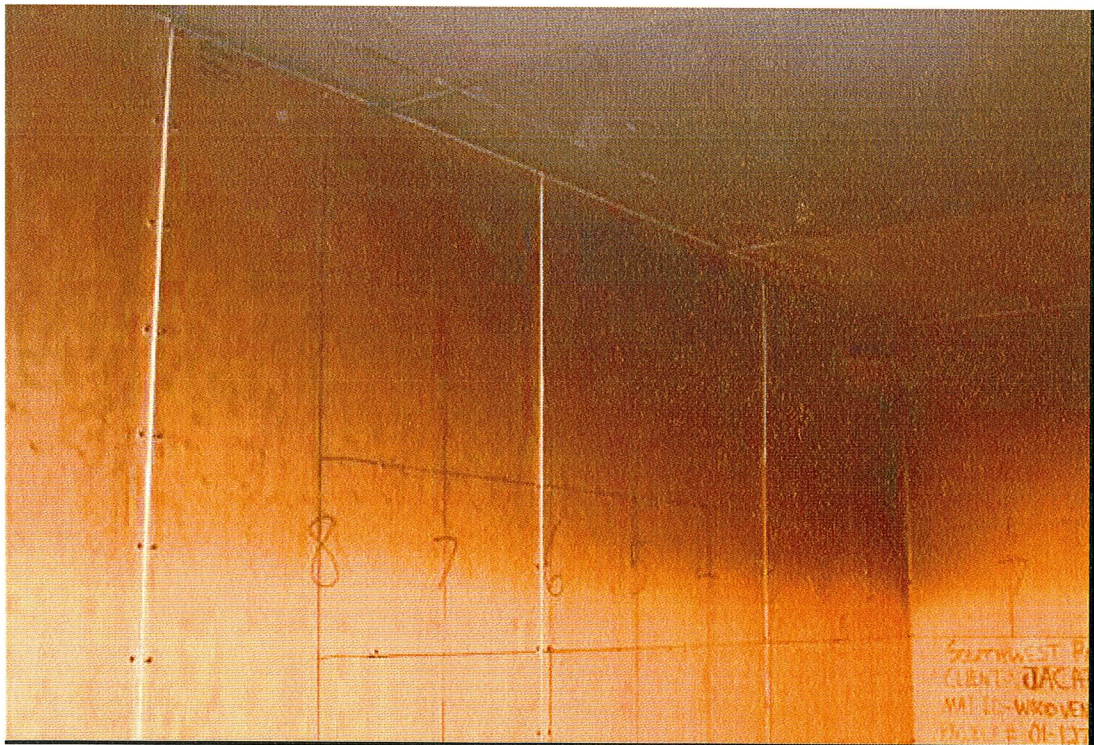
Figure B-10. End of Test; View of Left Wall.
